Manhole Inspection Summary

Manhole # S47KK_032MH

Insp Date: **5/5/08 1:21 PM**

Location Address: **Lanvale St**

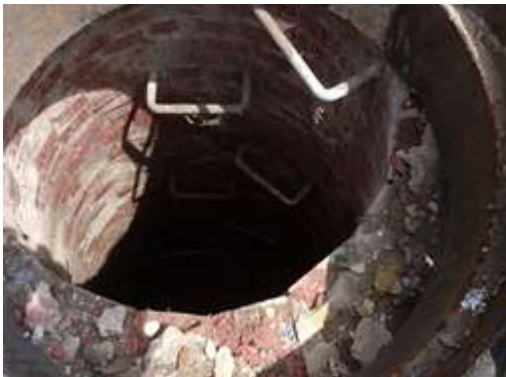
Defect 1

Infiltration: ☐ None ☒ **Joint** ☐ Cracks ☒ **Mortar** ☐ Roots ☐ Wall

Infiltration: ☐ None ☐ Joint ☐ Cracks ☐ Mortar ☐ Roots ☒ **Wall**

Infiltration

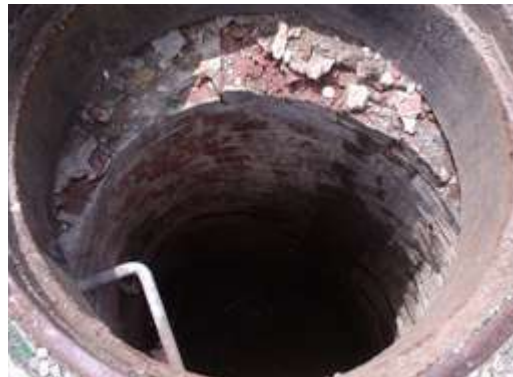
Defect 2

Condition: ☐ Sound ☐ Cracked ☐ Root Intrusion ☒ **Loose Brick** ☐ Deteriorated

Loose bricks

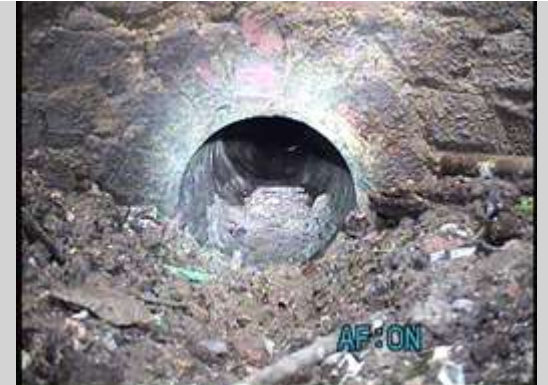
12 O'Clock Outflow

8 in. Circular Gravity Sewer
Pipe Out @ 12 O'Clock

Infiltration: **None** Pipe Seal Cond: **Sound**
